PENNSYLVANIA
ID NO. PA. 00789

IRONWORKS DAM

PHASE I INSPECTION REPORT NATIONAL DAM INSPECTION PROGRAM

June 1978

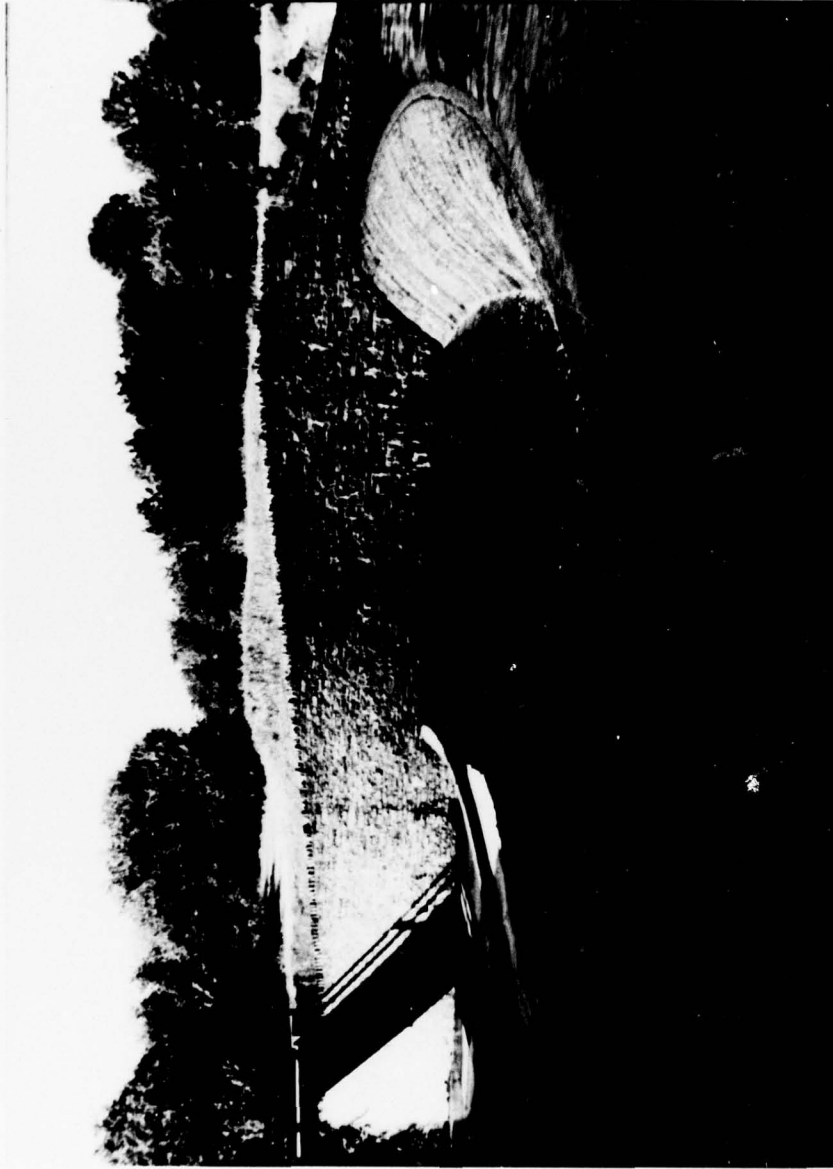
PHOTO NO. 2

LOOKING DOWNSTREAM OVER PRINCIPAL SPILLWAY FROM RIGHT
ABUTMENT (W/S) OF DAM. NOTE BRIDGE ON LEFT SIDE OF
PHOTO.

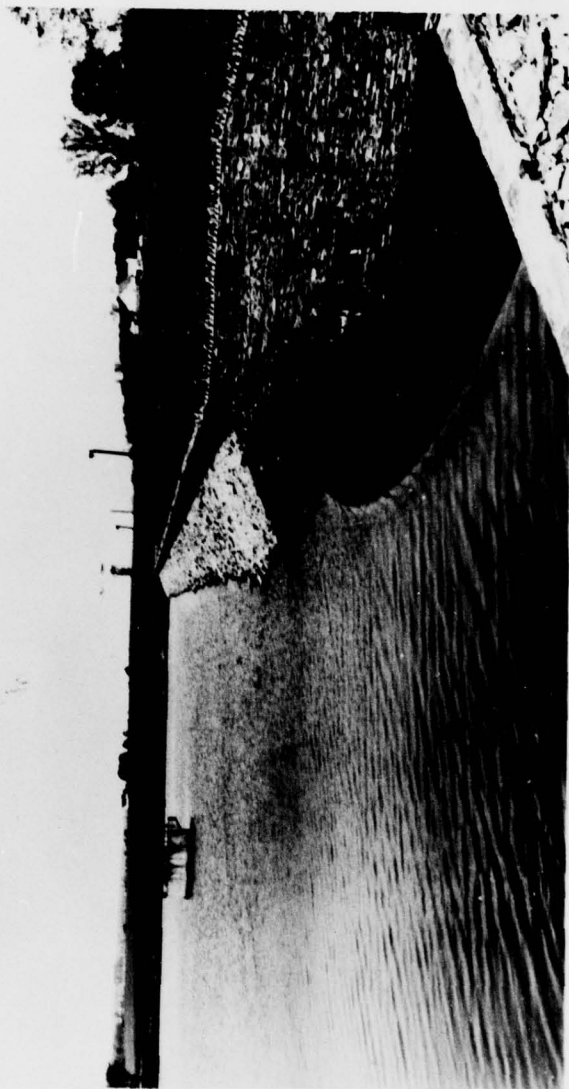
PHOTO NO. 8

PHOTOGRAPH SHOWS THE FINISHED RIPRAP SLOPE WHICH TERMINATES AT THE BASE OF THE PARAPET WALL. COMPARE THE FINISHED SLOPE SHOWN HERE WITH PHOTOGRAPH NO. 7 WHICH SHOWS THE SETTLEMENT OBSERVED DURING THE INSPECTION.

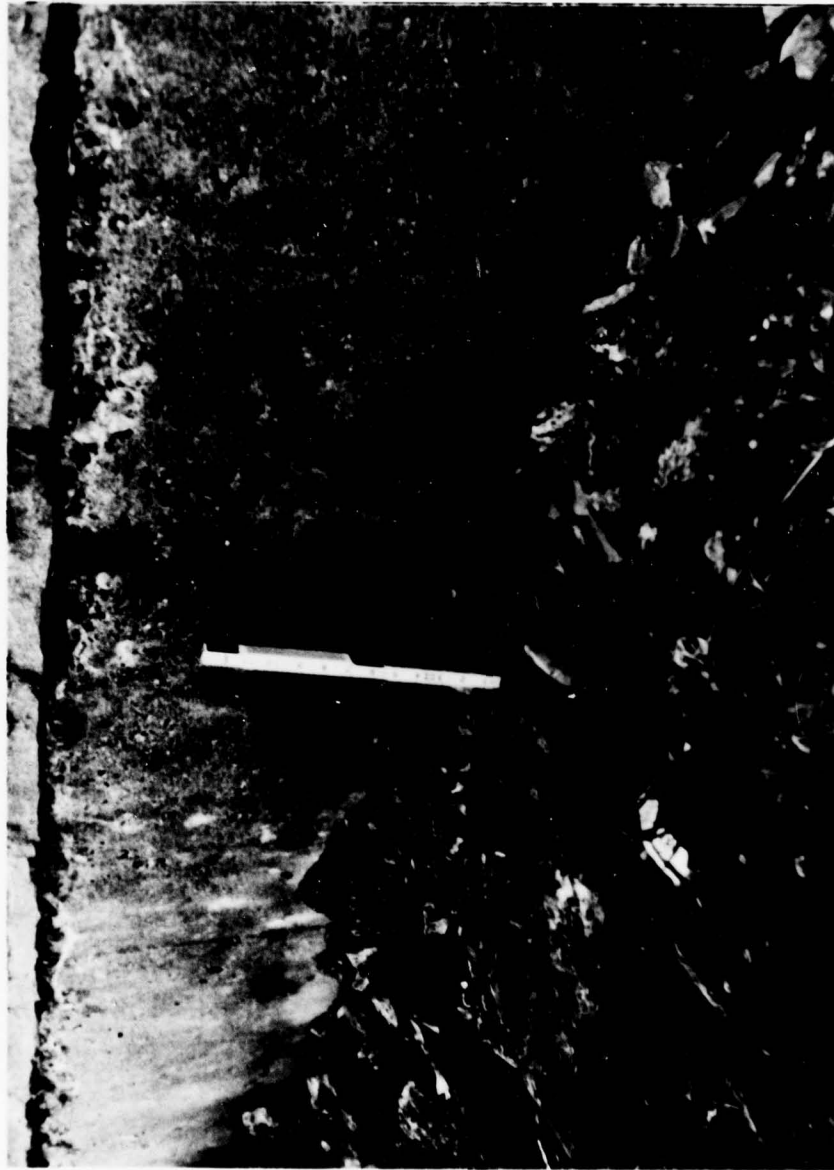
PHOTO NO. 9

CLOSE-UP VIEW OF SETTLEMENT ON THE UPSTREAM SIDE OF THE
CONCRETE CUTOFF WALL. APPROXIMATELY 18 INCHES OF SETTLE-
MENT WAS NOTED HERE.
